# Jane Pit, Workington

Assessment Report for a Community Excavation

Jane Pit, Workington  
Archaeological Assessment Report

Prepared on behalf of:  
Workington Town Council

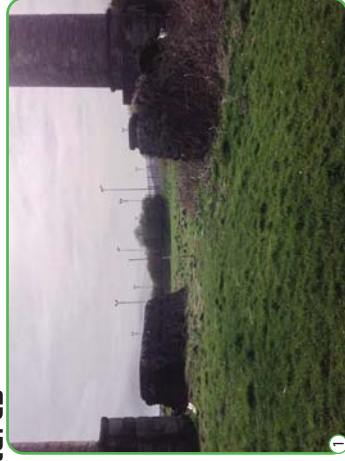
1 Connecting wall (left) (1006)

- 5.2.5 Two 4.5m long, parallel east to west aligned sections of standing wall were found to the northwest of the engine house, both made from a mixture of bricks and concrete. The southern feature (1006) was up to 1m wide in places and extended from the northwest corner of the engine house, and the northern one (1008) was of a similar size. Their size suggests they were designed load-bearing and similarly positioned holes in the centre towards the base of the structures may indicate they supported an axle for a large winding wheel. Beyond the eastern boundary of the Scheduled Monument was an earthwork that extended in a straight line for 30m east of the engine house, then continued a further 20m to the northeast (1007). This was the location of a large retaining wall on the northern side of a ramp, its purpose believed to be for the establishment of a yard to the north where a wagonway would have enabled the import and export of materials to and from Jane Pit. No structural elements of the retaining wall were visible on the surface due to extensive landscaping in this part of the site.

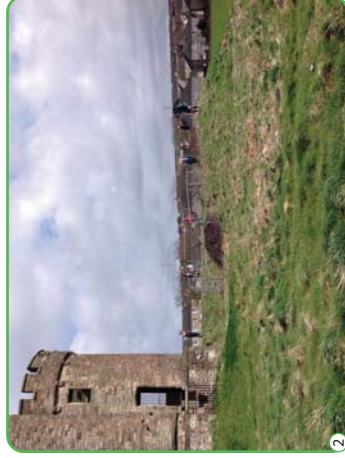
2 Horse gin pit (1001)

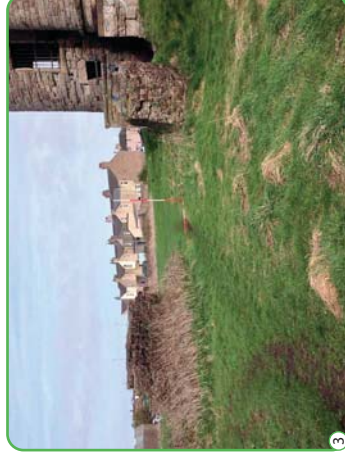
3 Brick and concrete feature (left) (1008)

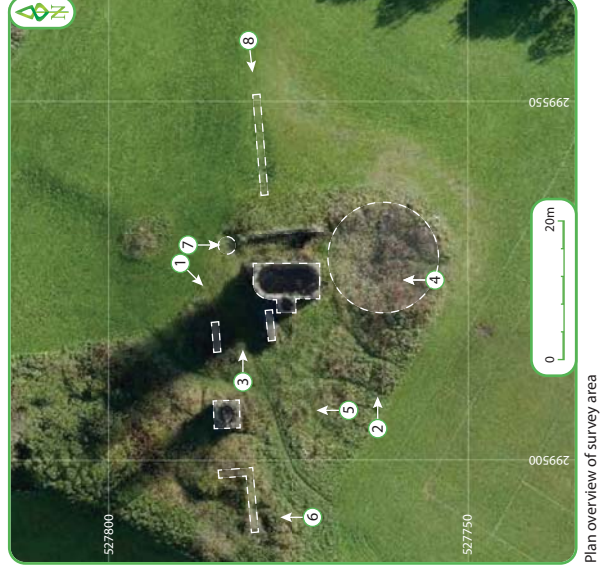
Plan overview of survey area

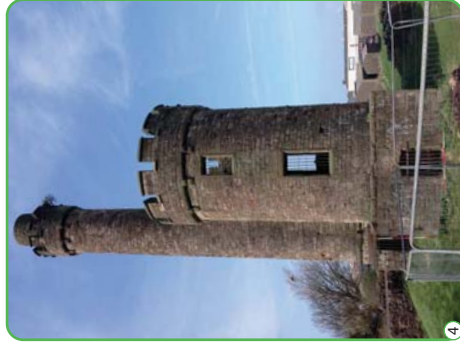
4 Engine house (1002)

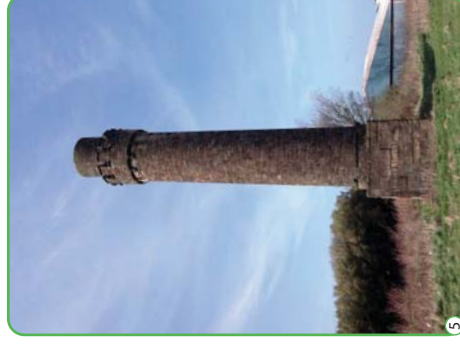
5 Western freestanding chimney (1003)

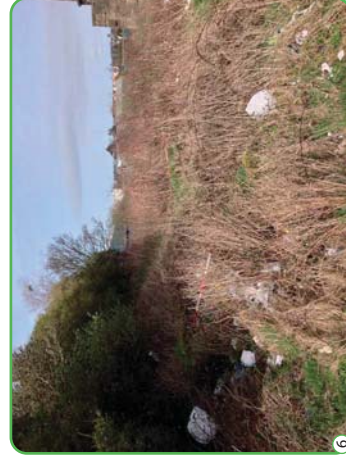
6 Rectangular building to west of freestanding chimney (1004)

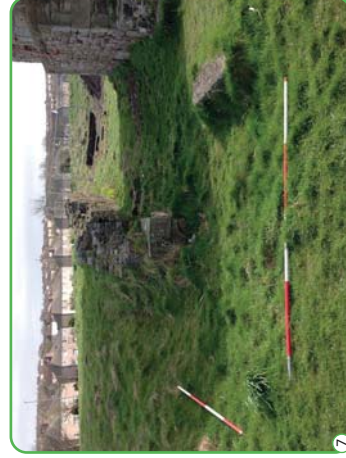
7 Shaft (1005)

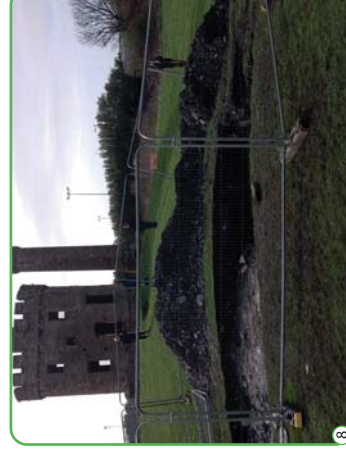
8 Retaining wall earthwork (1007)

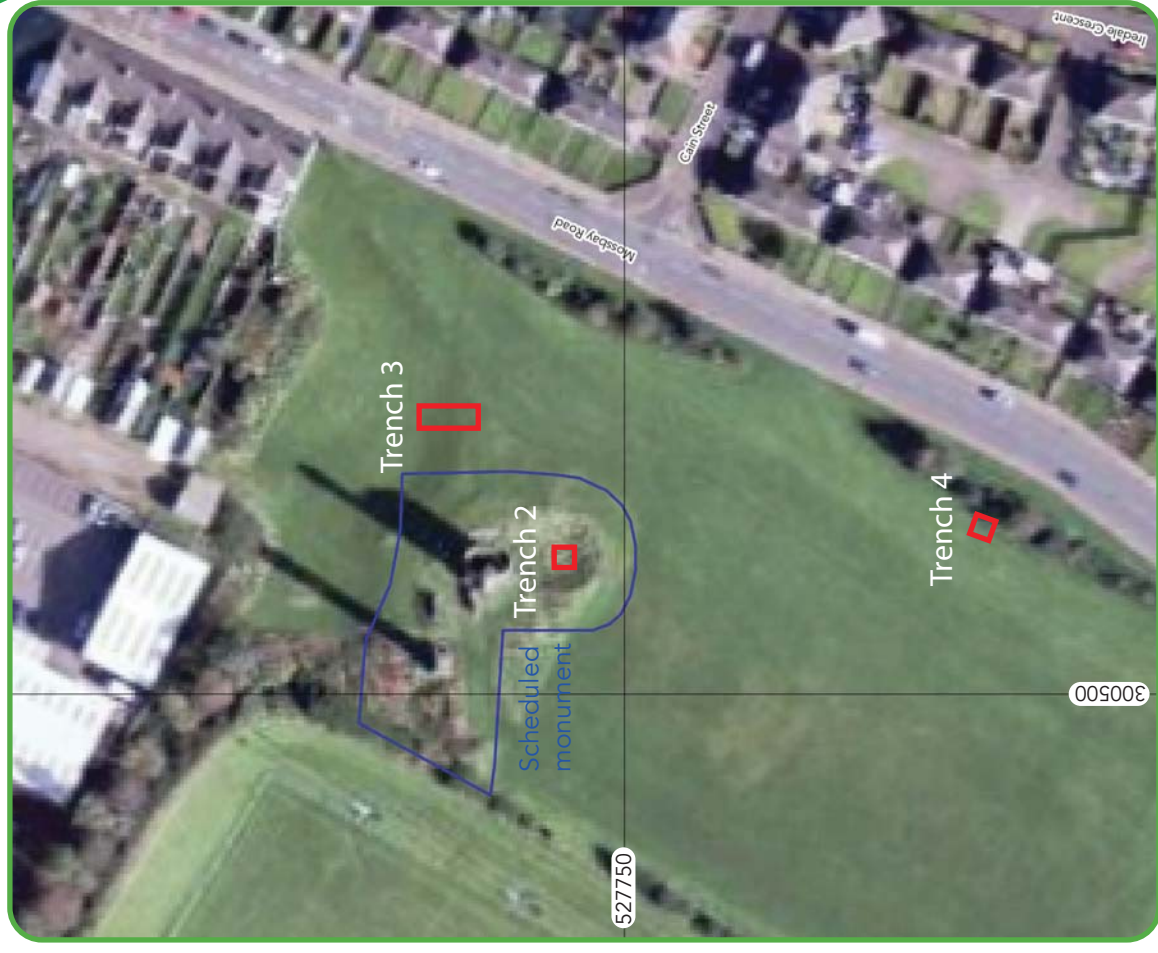
Figure 3 - Jane Pit: Trench locations

1864 Ordnance Survey Six-inch (Cumberland LIII)

2018 Google Earth Image Landsat/Copernicus © Infoterra Ltd & Bluesky

8.2.3 The accuracy of these documents, however, can only be assessed fully through archaeological excavation. Trenches were placed using a GIS making use of all available mapping. Their locations were then located physically using a dGPS accurate to within 2cm. In two cases, Trench 2 and Trench 3, features relating to the mapped evidence were located in their expected positions within these trenches. These show that the accuracy of these sources is high (metre accuracy). However, the excavated evidence from Trench 4 suggests that the location of Frostoms cottages were slightly offset from the features depicted, it only being through the knowledge of a nearby resident that the trench was moved to a correct location. As such, the form and location of Frostoms Cottages can better be determined to within a few meters of their physical location using map evidence and aerial survey (Q3).

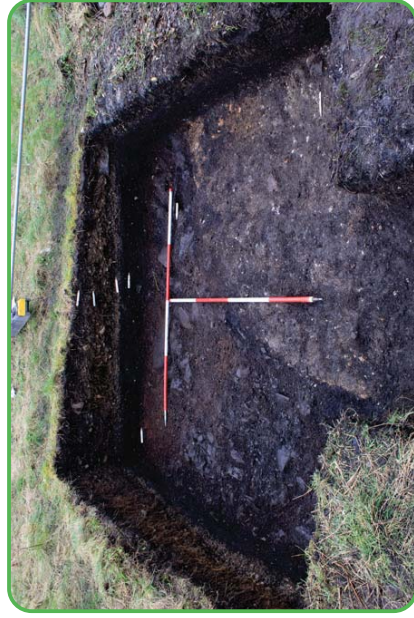
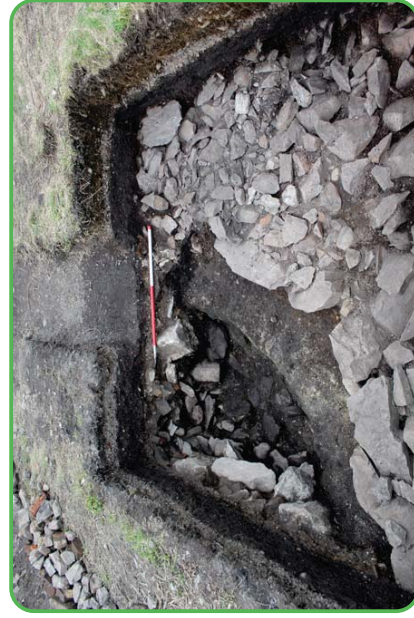
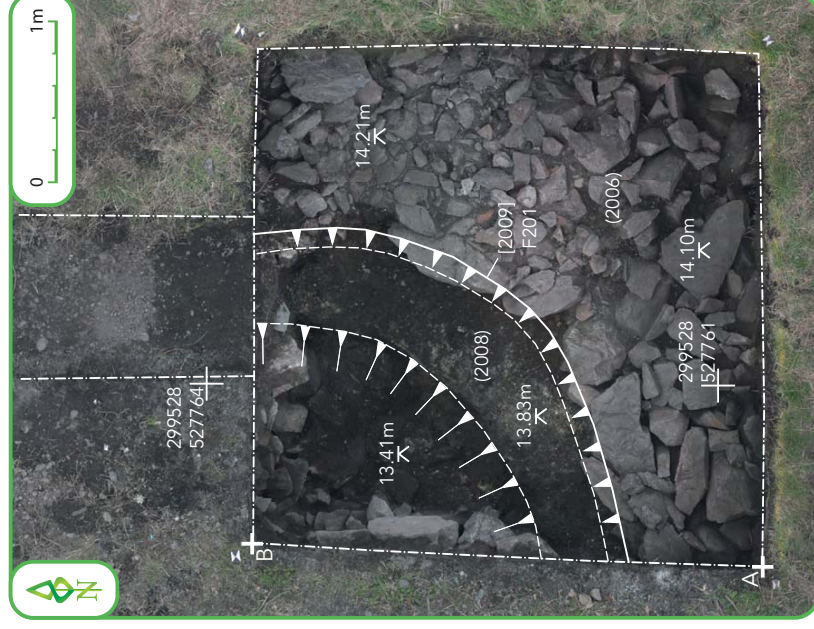
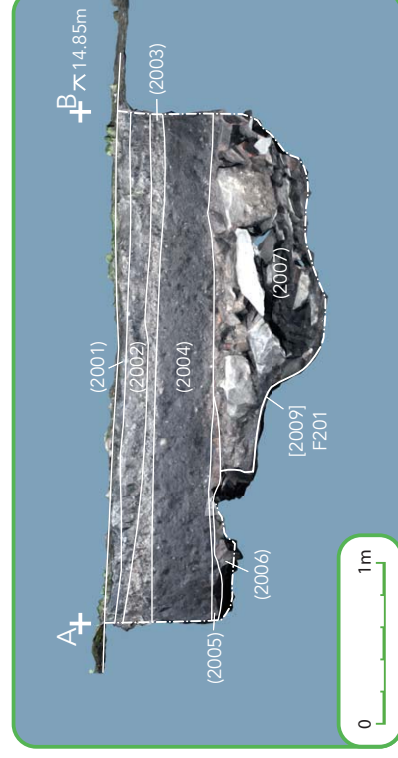
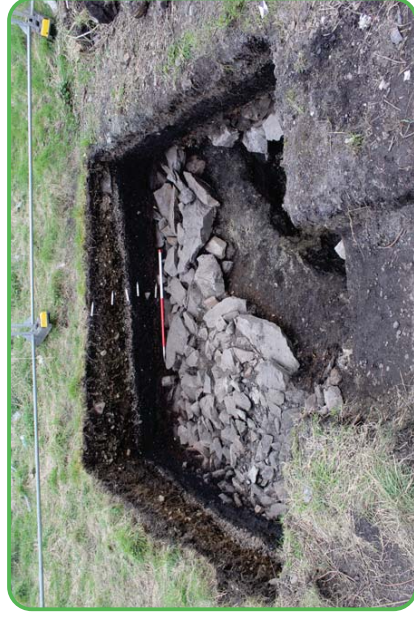
Figure 4 – Jane Pit: Trench 2 excavation results

Pre-excavation photo, looking south, 2m scales

Post-excavation photo, looking north, 1m scale

Post-excavation orthophoto plan

East facing orthophoto section

Post-excavation photo, looking south, 1m scale

- 5.4.1 Trench 2 measured 3m x 3m and targeted the circular earthworks identified as a Horse gin placed in the southern area of the scheduled monument. Initial attempts were made to remove the turf from this trench by hand using shovels and spades. However the topsoil was found to be too shallow for the integrity of any turfs recovered to be maintained.

- 5.4.2 The earliest layer encountered in this trench was a layer of compact silty sand (2008) that was yellowish brown in colour upon which was a 0.20m thick rubble layer (2006) of large boulders were loosely accumulated. This rubble layer appears to have been levelled by the pouring of a layer (2005) of crushed slag, or clinker, above it appearing as a dark red layer whose depth varied across the trench. A large oval pit, F201, was then cut into this layer.

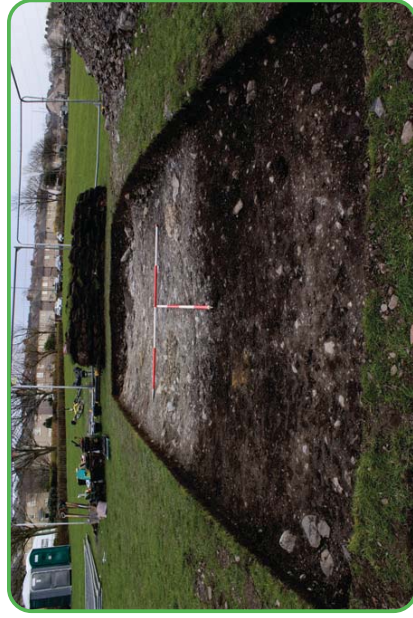
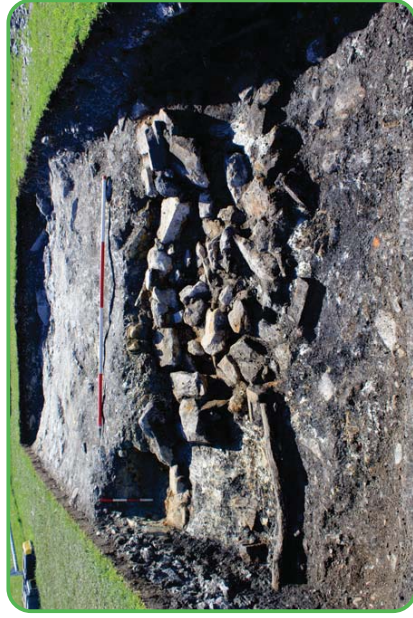
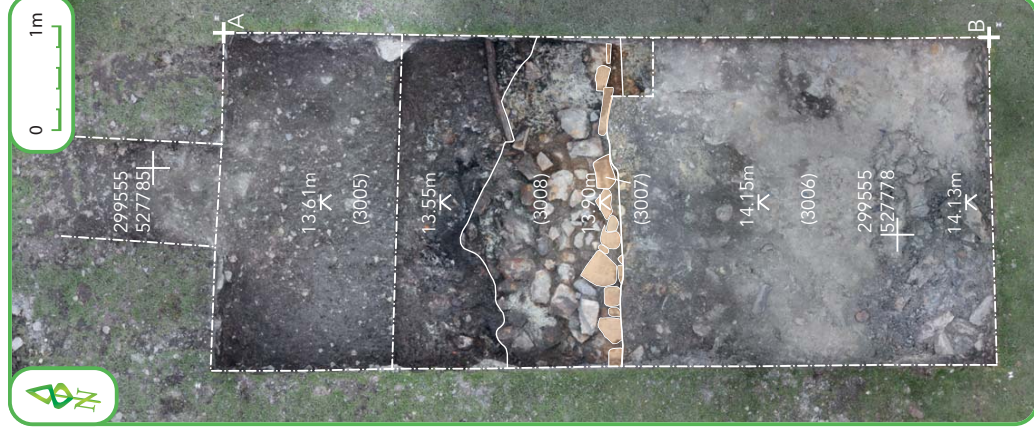
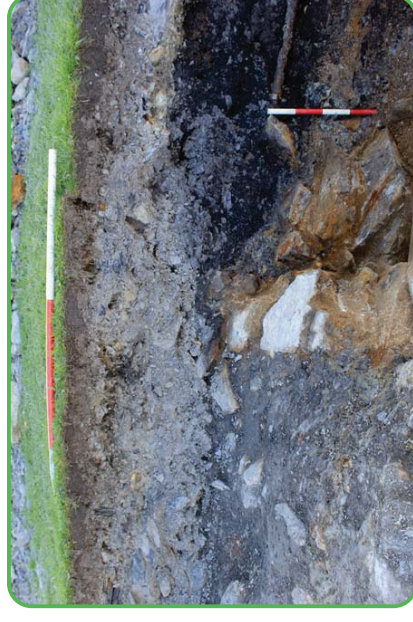
Pre-excavation photo of retaining wall, looking south, 2m scales

Post-excavation photo of retaining wall, its tumble, and the ramp, looking south, 2m scale

Post-excavation orthophoto plan

West facing orthophoto section

Photo of the retaining wall, looking west, 1m and 0.4m scales

- 5.5.2 The ramp (3006) was found on the southern side of the wall, having been built up against the original upstanding wall. It consisted of mostly thick light grey clay with

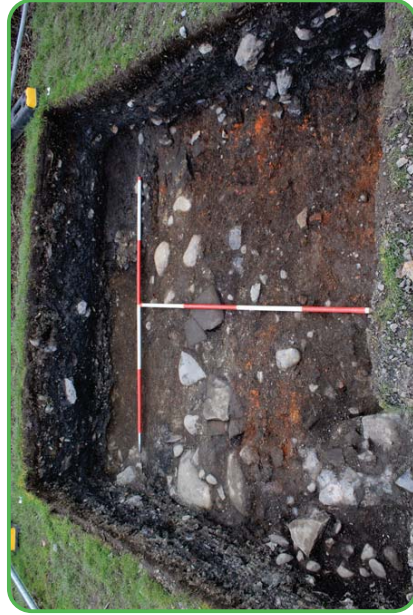
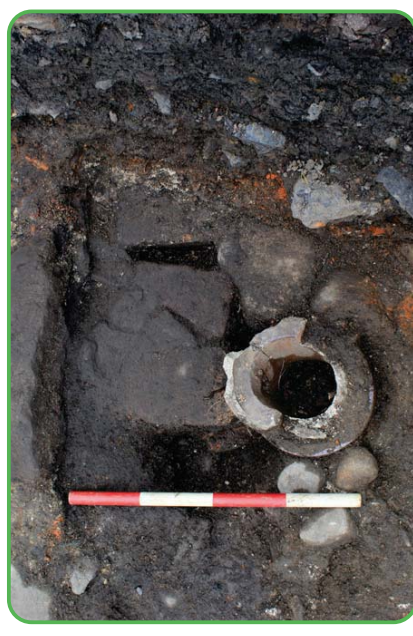
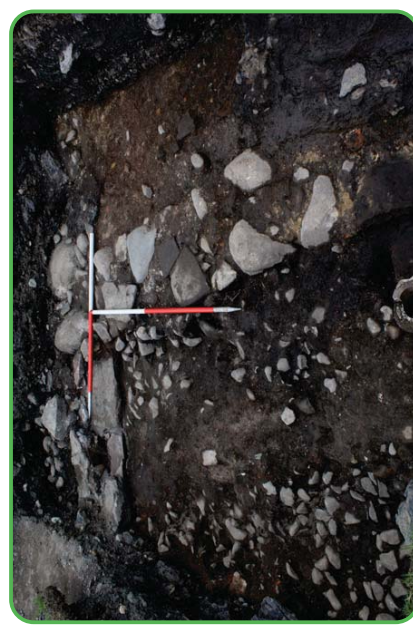
Pre-excavation photo, looking southeast, 2m scales

Post-excavation orthophoto plan

Northeast facing orthophoto section

Post-excavation photo of drainage pipe, 0.4m scale

Post-excavation photo, looking northeast, 1m scales

- 5.6.1 Trench 4 measured 3m x 3m and targeted the buildings northeast of the site labelled as Frostoms Cottages on historic maps. This trench aimed to confirm if any below ground archaeology remained in this area. This trench was initially staked out using a GPS based on historic mapping of the area; however, when in the field these co-ordinates were found to place the trench within the wooded border of the park area. Following advice from a local resident (Graham Williams), who stated that the buildings were situated opposite the front window of the house he still occupies, the trench was then moved 8m to the north. This advice proved valuable as the trench, upon excavation, successfully identified numerous features relating to Frostoms cottages.

- 5.6.2 The earliest features identified in this trench were three foundation walls marking out the edge of an outside yard and potentially the western edge of the cottage's interior. One, F401, ran for 2.90m and was oriented northwest to southeast while the two others, F402, F403, ran northeast to southwest for 1.10m and 0.30m respectively. Two of these walls were 0.44m wide and were made of angular slabs and sub-rounded boulders, bonded by white yellowish mortar, although only one these, F402, showed stones which had been hewn to a regular finish. The remaining wall, F403, was not excavated to the same extent but appears to have been made of similar material and was bonded with the same white yellowish mortar. The base of these all three features was not reached during excavation although each survived to a minimum height of 0.10m.

- 5.6.3 Following the erection of these walls the yard appears to have been levelled and cobbled (4006, 4015) as made evident by a layer of rubble found within the southwest corner of the trench. This yard was partially divided by a further, albeit much smaller, wall F404, although the relationships of this feature and the cobbles was not resolved during this season's investigations. The smaller wall F404 was approximately 0.30m and 2.05m wide, which in effect created a sub space within the yard's eastern area approximately 0.60m wide and at least 2.00m long. A vertically standing drainage pipe F405 was found to be placed within the southern end of this bounded space making it likely that this was an outside privy associated with Frostoms cottages.

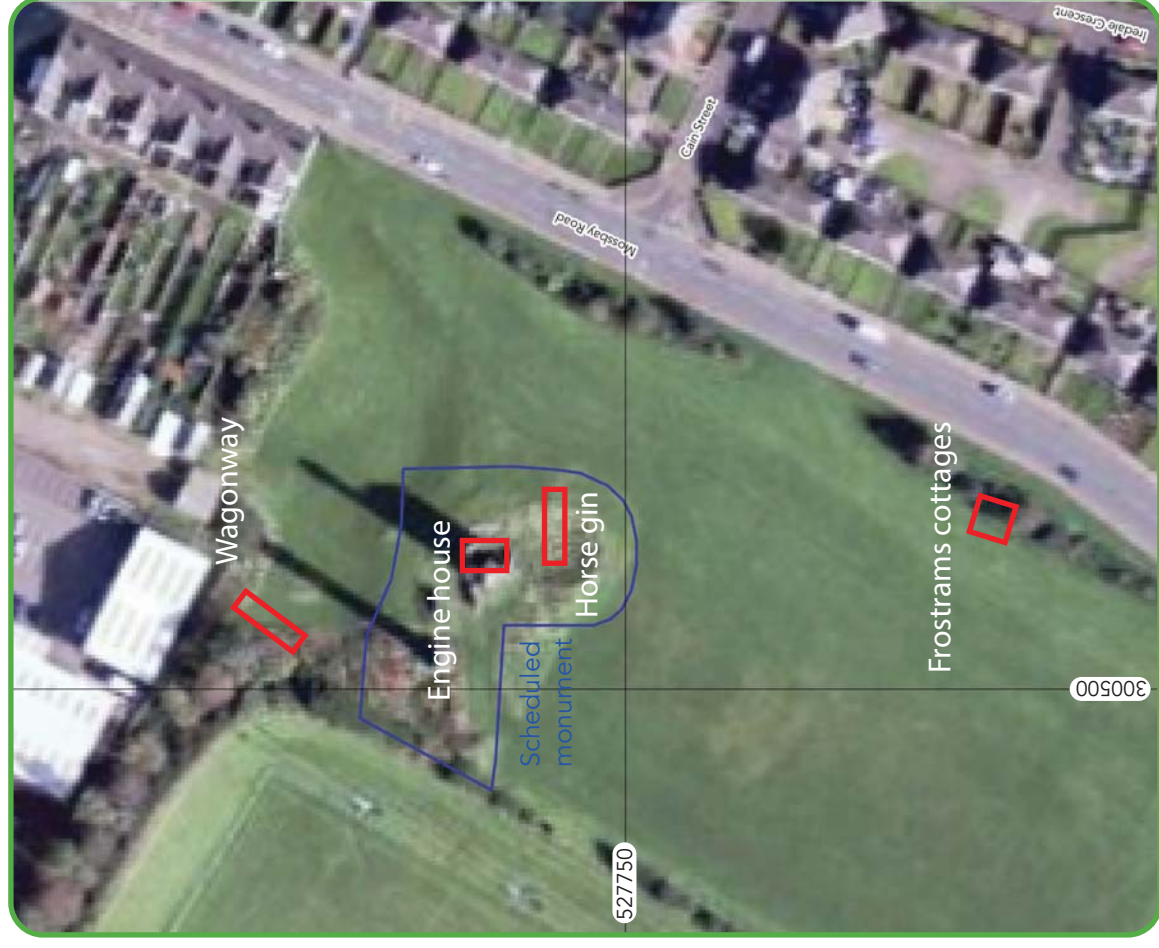
Figure 7 - Jane Pit: proposed areas of future archaeological investigation

1864 Ordnance Survey Six-inch (Cumberland LIII)

2018 Google Earth Image Landsat/Copernicus © Infoterra Ltd & Bluesky

- 10.2.1 Investigations undertaken in 2018 have highlighted a number of potential targets for a second excavation season. These include features relating to the use and functions of Jane Pit, in particular the engine house, the horse gin and the wagonway (see Figure 7). In addition, extending the trench investigating the location of Frostoms cottages would aim to reveal information relating to use of these buildings and the phasing of associated activities.
